# ESD in hydraulic filters

The study covered by this article stems from the need to understand and solve the problem of electrostatic discharges within hydraulic filters, resulting from the accumulation of electrical charge caused by the passage of oil inside them

by Emanuele Villa and Alessandro Negri

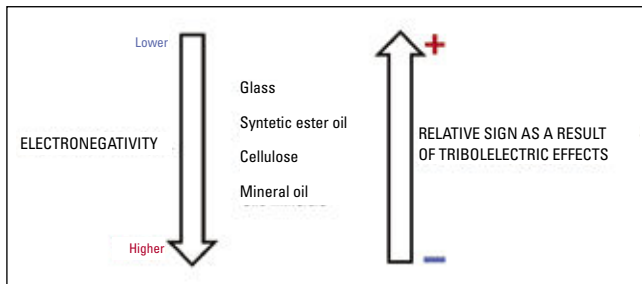
> FIG. 1 - Triboelectric scale for material of interest

of their constituent elements. The **Fig. 1** shows the triboelectric scale (which provides information on the relative electronegativity) for the materials under examination: cellulose, glass, oils (similar to hydrocarbon derivatives). In the triboelectric effect, the body with greater electronegativity snatches electrons from the other, generating an accumulation of net negative charge on itself, charging the other by the same amount, but with opposite sign. In liquid-solid systems, contact is sufficient to generate this type of effect (**Fig. 2**). At the microscopic level, a *double layer*, is formed, consisting of an accumulation of surface charges (*Helmholtz layer*) on the filter material and a *diffuse layer* in the oil volume, whose charge distribution is exponential (**Fig. 3**). If the fluid is moving at a certain flow rate (**Fig. 4**), the flow carries away the charges in the liquid and causes an accumulation of net charge in the system, which gives rise to high potentials (up to tens of kV). The dissipation of the charge can occur through conduction or electrostatic discharge processes. The former are various, but it is useful to focus on the main dissipation mechanism in fluids: charge relaxation, represented in **Fig. 5**.

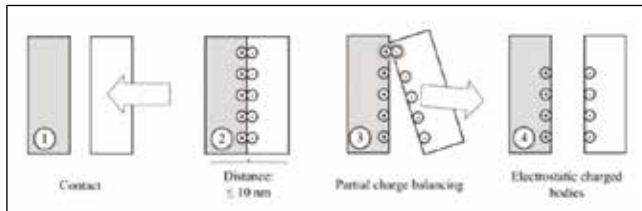
> FIG. 2 - Triboelectric effect by contact

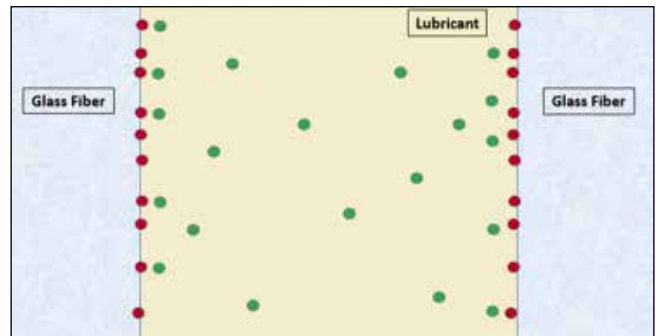
> FIG. 3 = Electrostatic double layer (da STLE annual meeting 2016, W. Needleman)

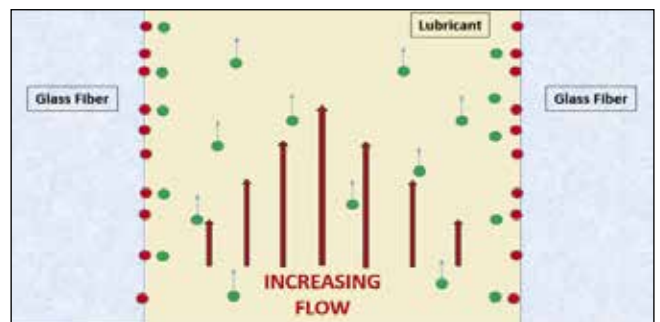
> FIG. 4 - Formation of net charge accumulation (from STLE Annual Meeting 2016, W. Needleman)

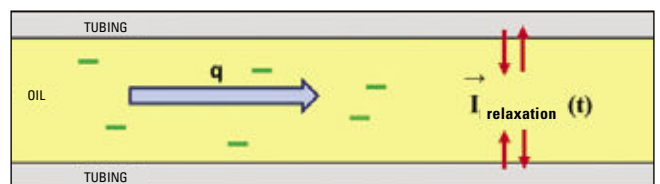
> FIG. 5 - Charge relaxation in the pipes

This occurs when the pipes or tanks in which the liquid passes or is contained are conductive (and connected to earth); through convective motions, attracted by the zero earth potential, the charged particles tend to approach the walls, where they release the accumulated charge. In solid insulating components such as plastics, however, only conduction currents are generated which, by dissipating the charge, prevent the accumulation of potential from diverging. Rather, the voltage is expected to reach a maximum value when the accumulated charge equals that dissipated. The charge accumulated in the system, in addition to being dissipated by conduction, sometimes gives rise to discharge phenomena. An electrostatic discharge is the passage of electrons through an insulating medium, the result of which is to bridge the potential difference between two areas of a body or between two distinct bodies,

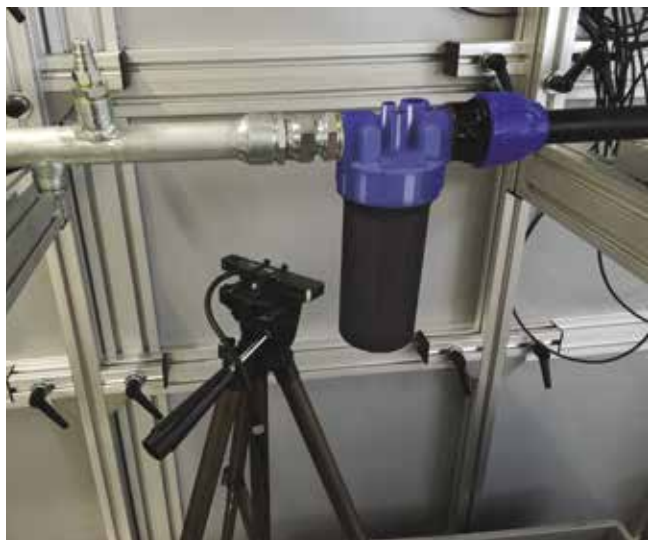
> Voltmeter that measures the filter potential

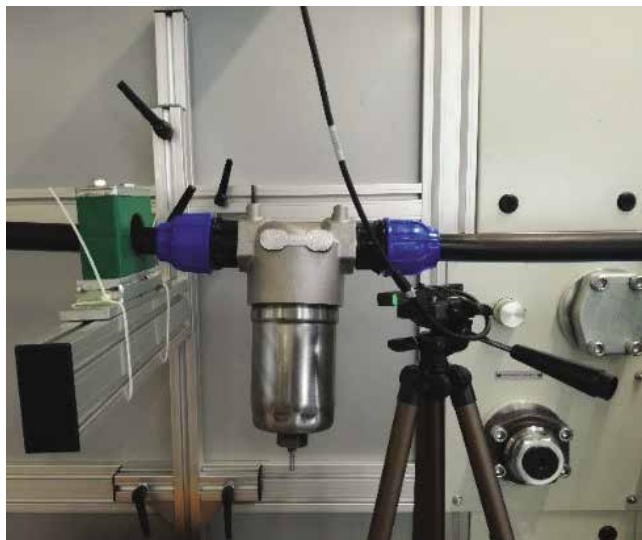
> A charge collector integrated into the circuit

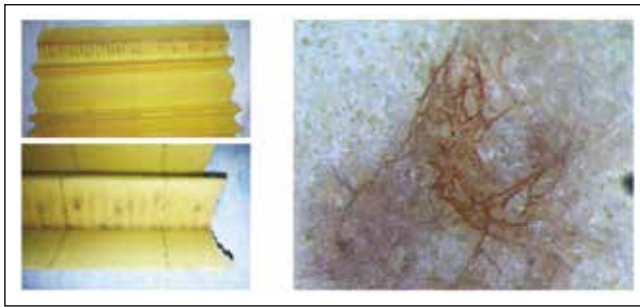
> FIG. 7 – Image of a cellulose septum damaged by the discharge and microscopic detail of the affected area

Significant damage to the filter material has been observed on the cellulose elements, both with the naked eye and using an optical microscope (Fig. 7), while the plastic components show no major damage except in the intersection between the spiral tube and the metal head. Therefore, it is assumed that the discharges occur between the filter body and the internal support metal tube, from which the electric charge then passes to the metal head through a further discharge. As for the glass fibre filters, significant damage is observed only at the level of the bead and of the glue that joins it to the rest of the filter. The burns are visible on the surface and also extend inside the material (Fig. 8), compromising its mechanical strength. Finding that the fracture line follows the lines of damage caused by discharges (discharges that

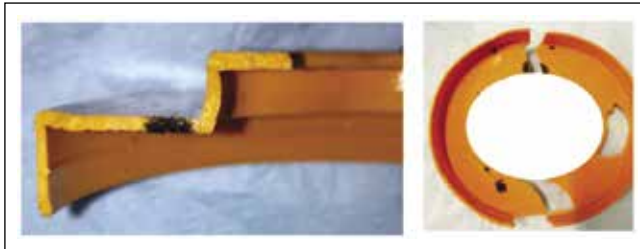
> FIG. 8 - Detail of the bead core of a glass filter damaged by drains

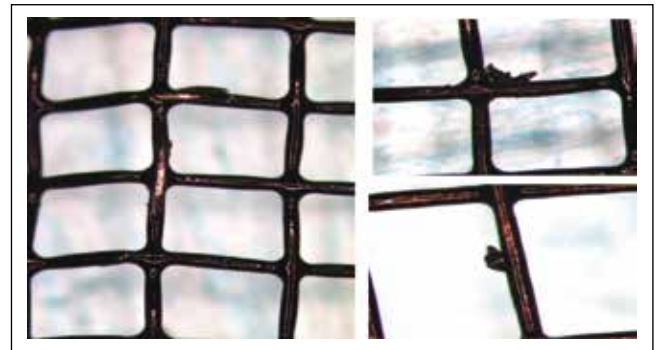
> FIG. 9 - Images of the epoxy network at various magnifications

damage the filter material do not occur, also because the glass fibre has a dielectric strength of about 200 kV/mm, much higher than those reached in the system). In addition, minor damage can be seen on the epoxy resin coating of the metal mesh, an element present in the body to hold the different layers together (Fig. 9). The hypothesis, in this case, is that the charge accumulated on the filtering material is collected by the epoxy network, in which a conduction current passes through the coating of epoxy resin (insulator) which causes damage to it. From the network, the charges are then dissipated reaching the metal head through electrostatic discharges. In fact, discharge signs can be observed in the glue that follow the profile of the network embedded in it.

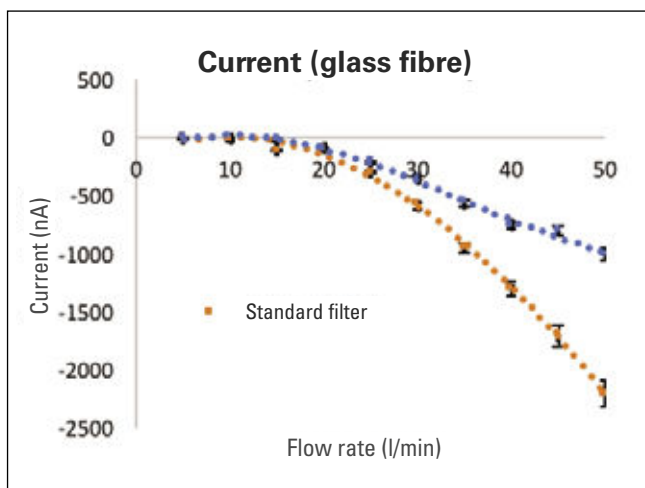
Graph 3

For the glass fibre models the currents (**Graph 3**) have higher values than those in cellulose, but for both the order of magnitude is  $\mu\text{A}$ . There is an improvement in using the dissipative elements, despite which, however, no net charge is observed in the oil. The triboelectric effects therefore appear to be minor using dissipative elements, but the oil charge effect due to the passage in the filter materials is not avoided. The trend of the measured current appears to be, similar to the potential, a rapid but not exponential growth. However, there is no damping of current growth at high flow rates, so that the (asymptotic) saturation trend observed for voltage is not repeated. It is believed that this
